Title: Bhopal Revisited

Intended for: Nuclear Explosive Safety Workshop 2015, 2015-04-28 (Albuquerque, New Mexico, United States)

Tom Jones, LANL, W-10
Stationed at the Pantex Plant

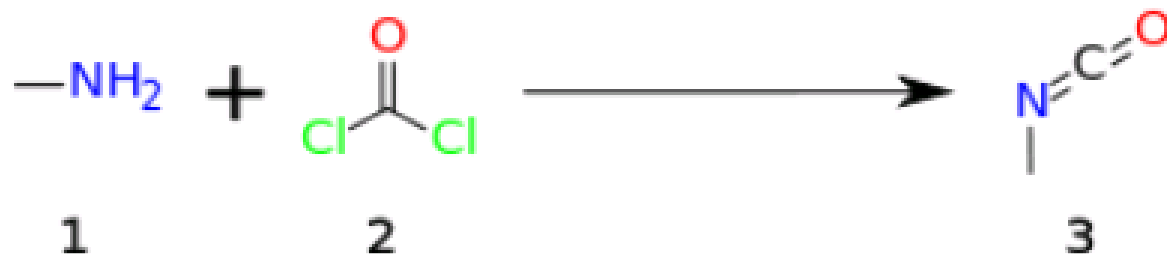
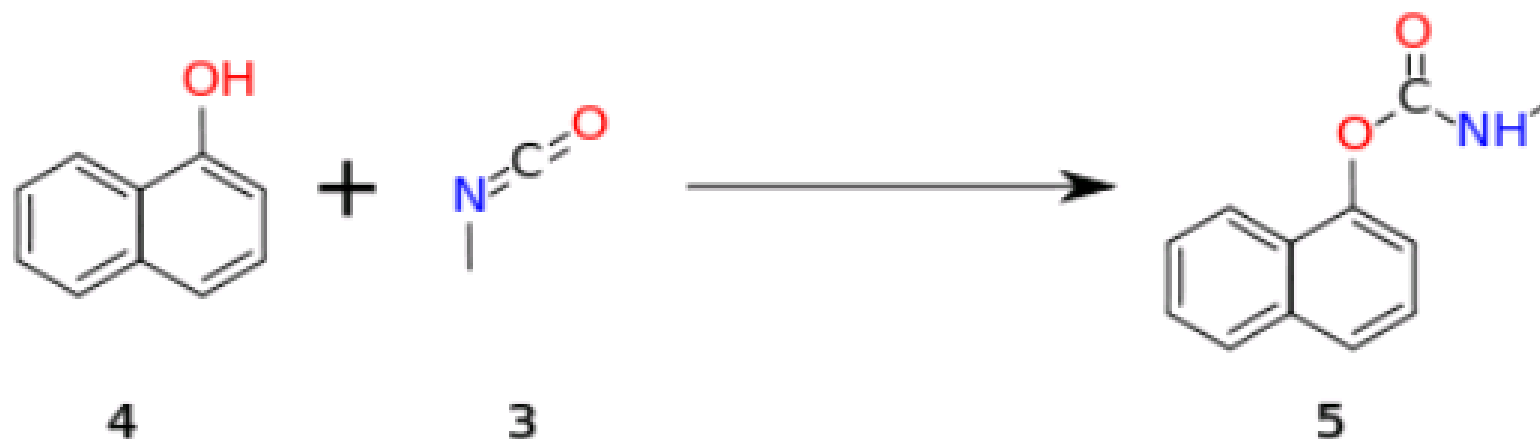
The Chemistry

Methylamine (1) reacts with phosgene (2) producing methyl isocyanate (3) which reacts with 1-naphthol (4) to yield carbaryl (5)

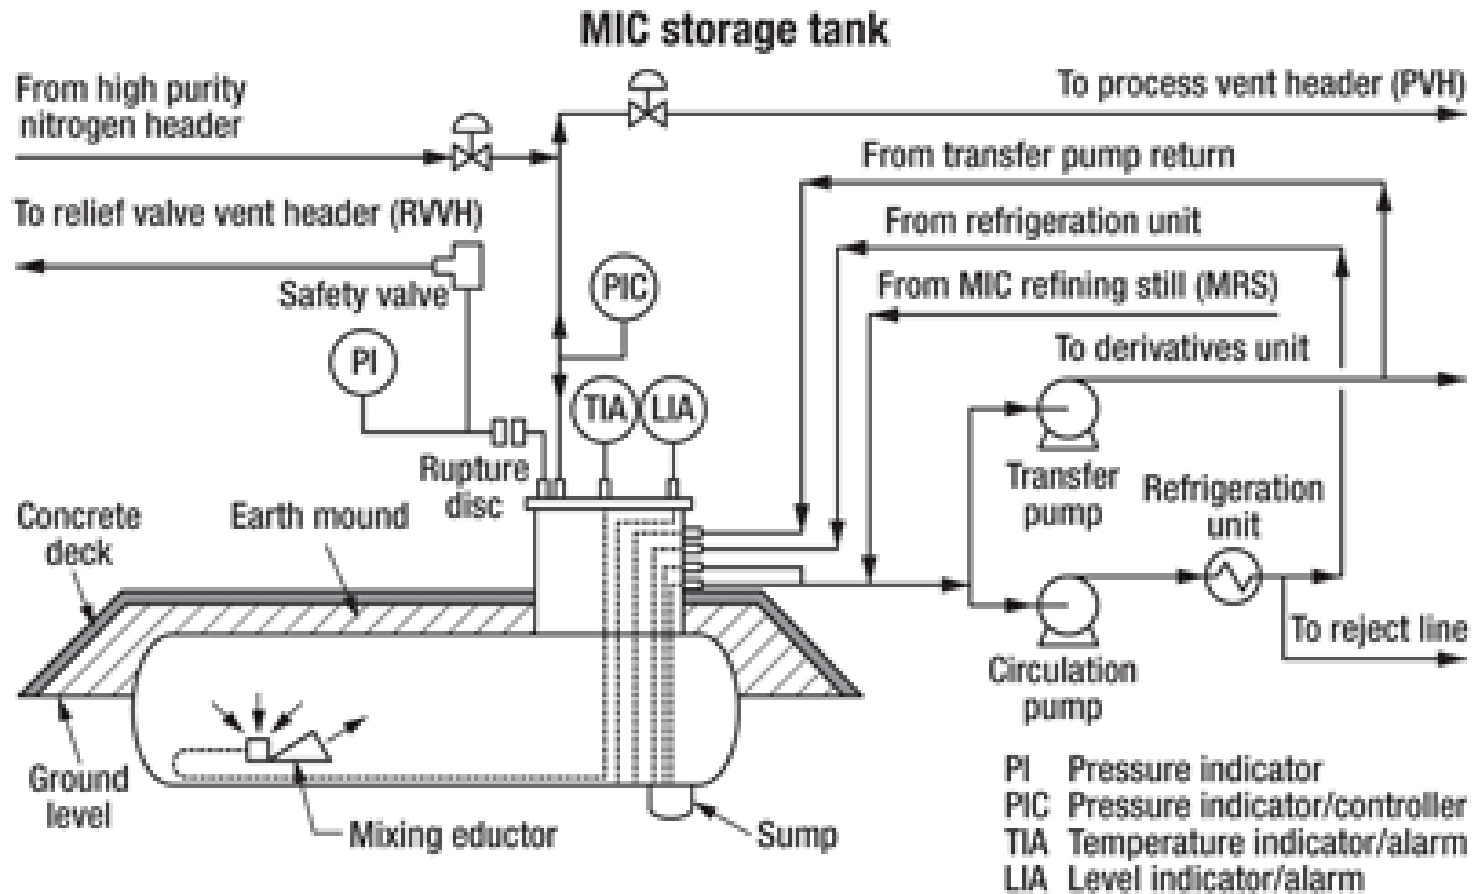
MIC Storage

- MIC reacts with normal Carbon Steel
- Requires use of nitrogen blanket on unprotected pipes, tanks and valves
- MIC produced was stored in two stainless steel storage tanks, designated as Tanks 610 and 611. An identical tank (Tank 619) received contaminated material from either Tank 610 or 611 on an emergency basis
- A nitrogen blanket was used to maintain slight pressure inside the MIC storage tanks while continuously purging MIC vapor into the process vent header (PVH).
